Monitoring API 610 pumps
Use Case: Refinery

BestSens

Refinery In Venezuela

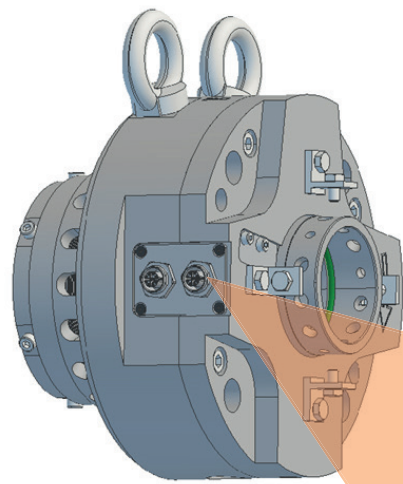
Double acting mechanical seal with integrated sensors

In the course of this, the design of the seal was revised and this double-acting mechanical seal with matching locking system was installed in the pump. The seal was designed with the special requirements of the plant operator in mind and is also equipped with the integrated sensor solution for pump monitoring from BestSens AG to enable conclusions to be drawn about seal condition in the future and to make downtimes a thing of the past. In addition to monitoring the seal, BestSens AG's complete pump monitoring solution, the Pump Monitor, was installed in the South American plant.

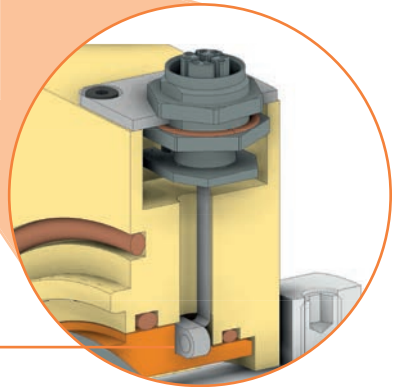
Attachment of the sensor to the counter seal ring

The Pump Monitor checks two API 610 refinery pumps, their seals and bearings, as well as both pumps temperature, vibration, and pressure level and flow of the barrier system. The sensor measures temperature and lubrication state on the seal faces. On the software side, the Pump Monitor is equipped with a dashboard that outputs the plant overview, which can be used by service personnel on site to identify and troubleshoot potential problems. In addition, the data is transferred to the refinery's control center, where staff can remotely obtain an overview of the pump status.

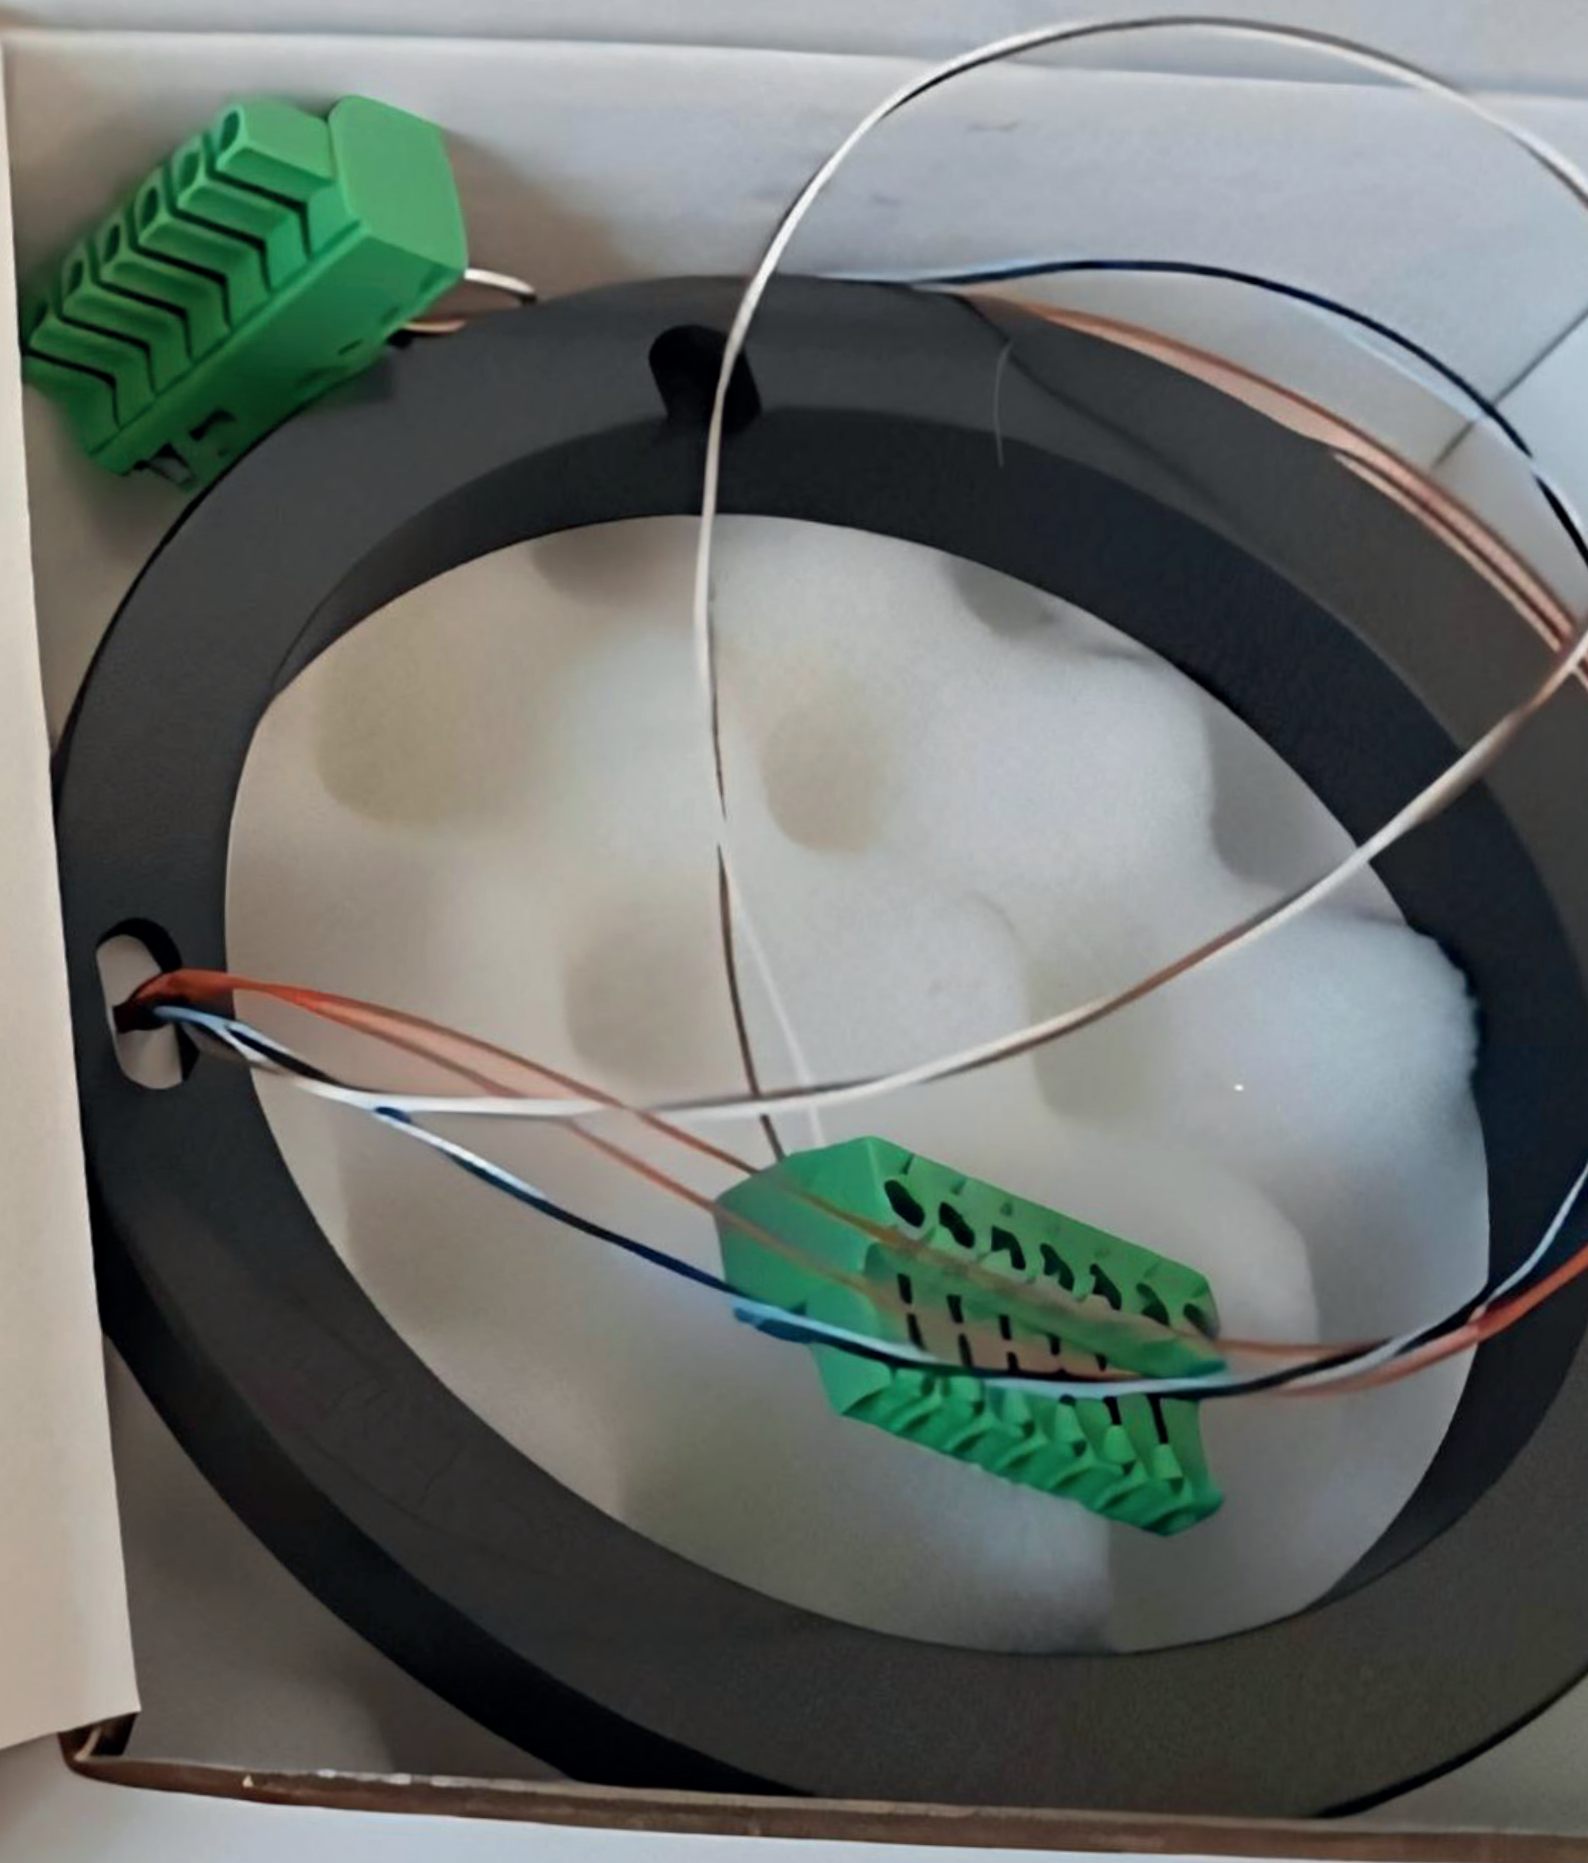
Parts of the double-acting mechanical seal with integrated BestSens sensors as an intermediate step in production.

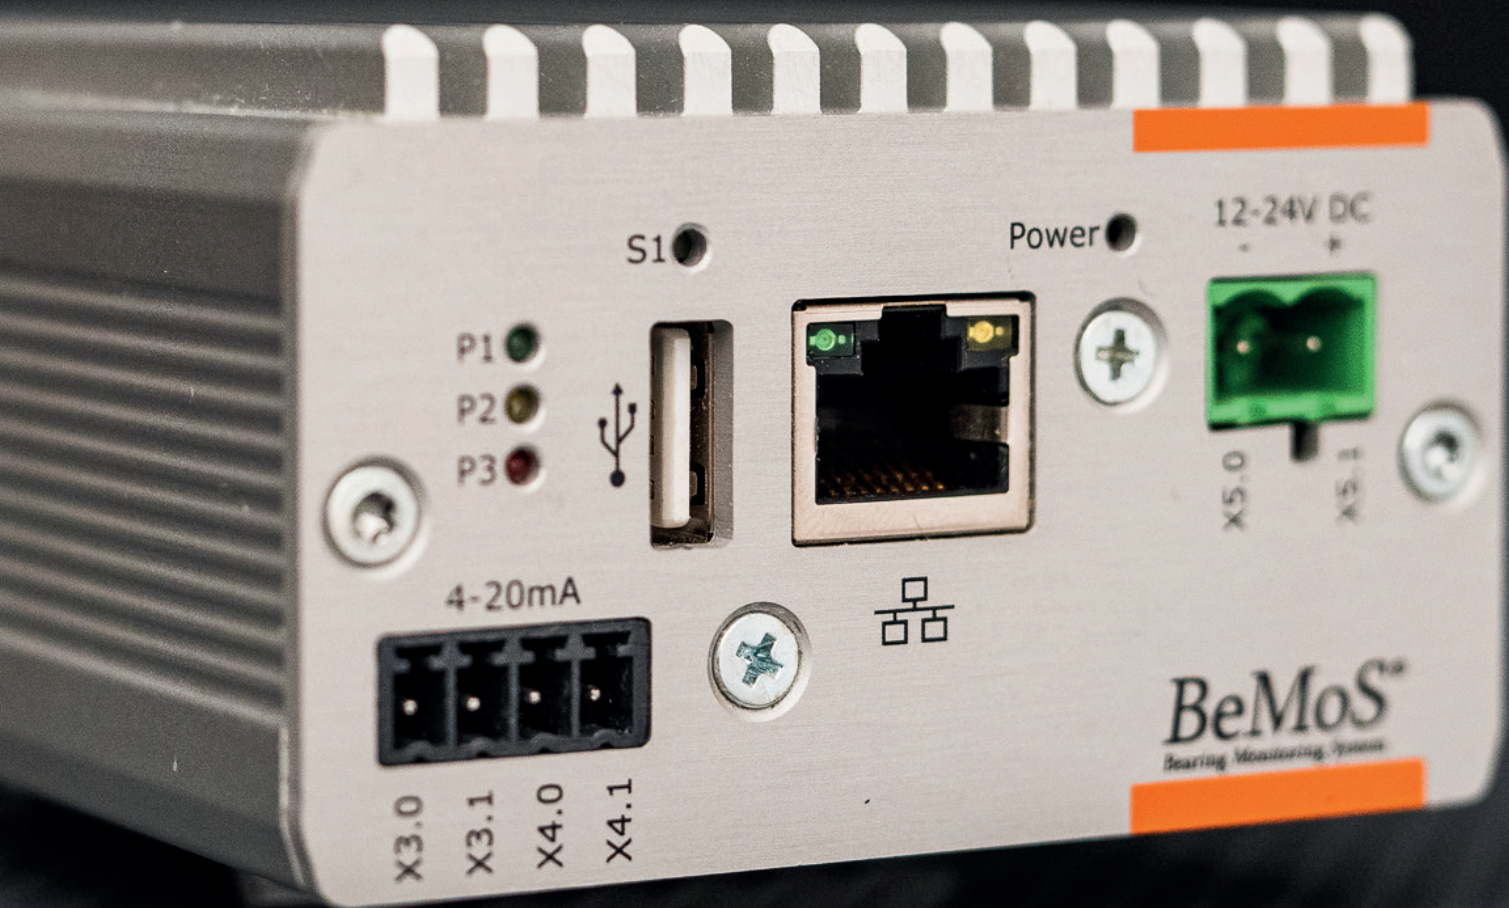
BeMoS controller, heart of the Pump Monitor
